THE EFFECT OF EXPOSURE TO COASTAL CLIMATE ON DURABILITY OF LOW-RISE BUILDING ENVELOPES IN NORTHWEST COAST RESORTS

Ihab F. Rashed

Azza S. Wahba

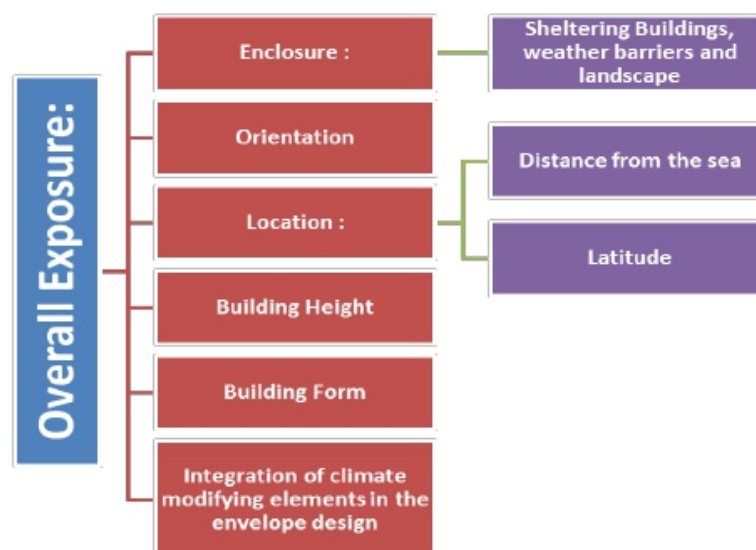
The significant Design Parameters that affect the durability of the exterior finishing materials are presented and summarized in Fig. (6).

Fig.(6) The Design Parameters that affect the durability of the exterior finishing materials

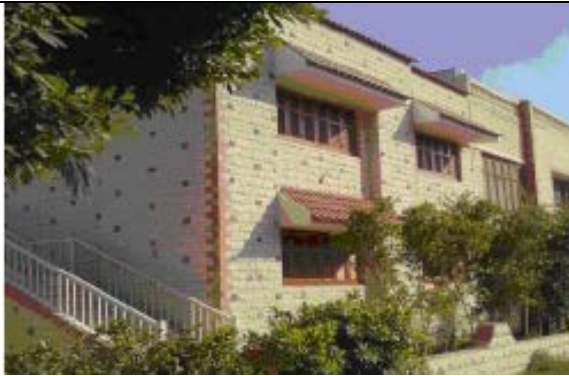
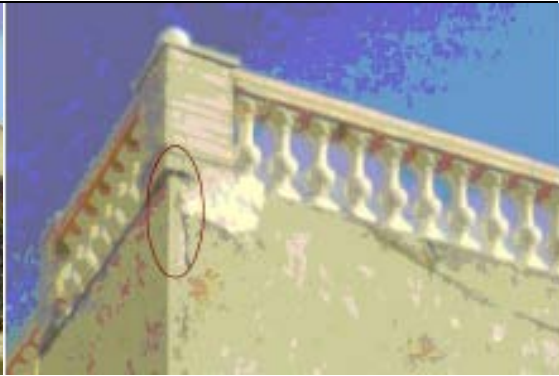
Stone /Brick Veneer		Render Finish	
First Row: Exposure: Average		Orientation: South – South West Facades

Heat Damage by solar radiation: Cladded parts of the wall were found in a very good condition		Heat Damage by solar radiation: Render finished Southern walls : Cracks at corners due to thermal expansion in non-cladded buildings. Loss of Pigmentation due to UV Radiation.	
Exposure: High		Orientation: Western Facades

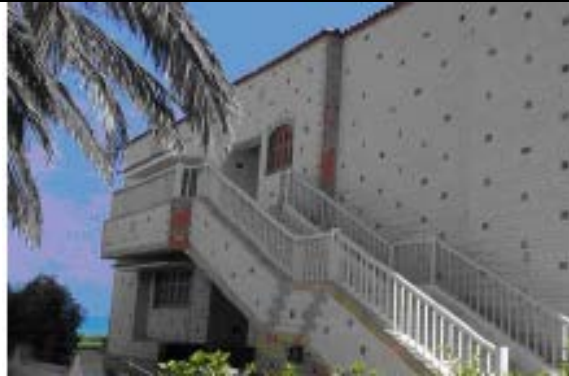
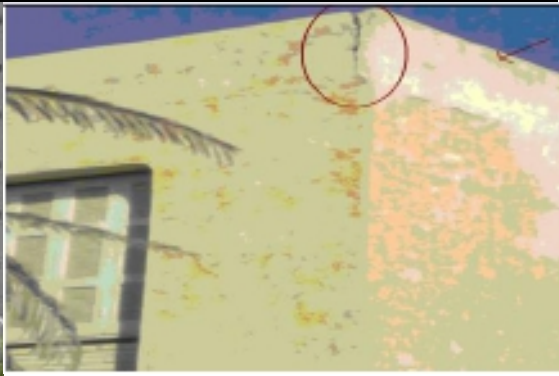
Heat Damage by solar radiation: Cladded parts of the wall were found in a very good condition		Heat Damage by solar radiation: Corner cracks in parapet walls due to thermal expansion in non-Cladded buildings. Loss of Pigmentation due to UV Radiation.	
Exposure: High		Orientation: Eastern Facades

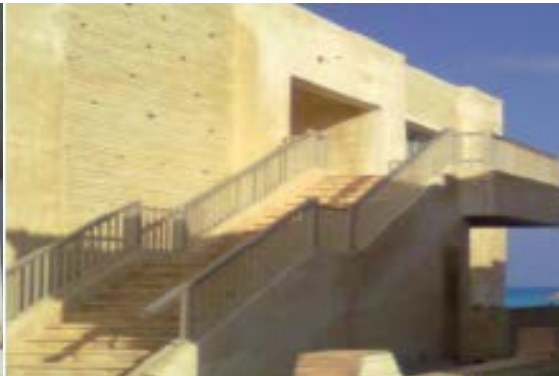
Heat Damage by solar radiation: Cladded parts of the wall were found in a very good condition		Heat Damage by solar radiation: Render Finished parts of the wall were found in fair condition

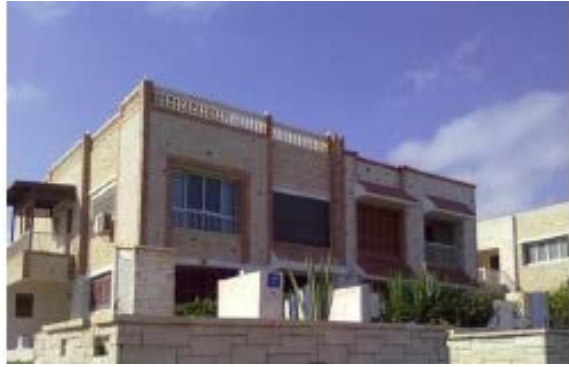
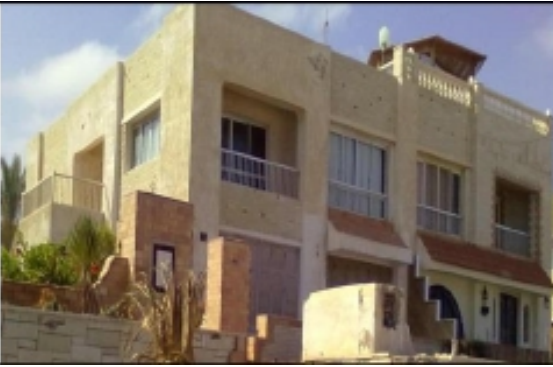
Stone /Brick Veneer	Render Finish
First Row: Exposure: Average	Orientation: North – Nort East Facades

<p>Moisture damage by rain and humidity: Cladded parts of the wall were found in a very good condition</p>	<p>Moisture damage by rain and humidity: High moisture content in corner parapet wall caused partial peeling in wall render finish due to water ingress at the intersection line between the roof slab and the wall. (Moisture carried by high wind velocities, together with probable accumulation of rain water.)</p>
Second Row: Exposure: Average	Orientation: South Facades

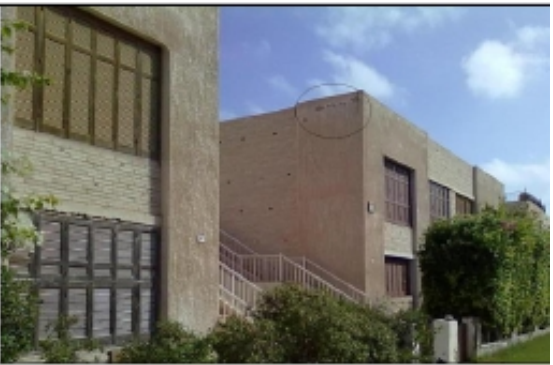
<p>Moisture damage by rain and humidity: High moisture content in corner parapet wall caused partial peeling in wall render finish due to water accumulation on the roof surface and absorption at the intersection line between the roof slab and the wall.</p>
Second Row walkway: Exposure: High	Orientation: Western Facades

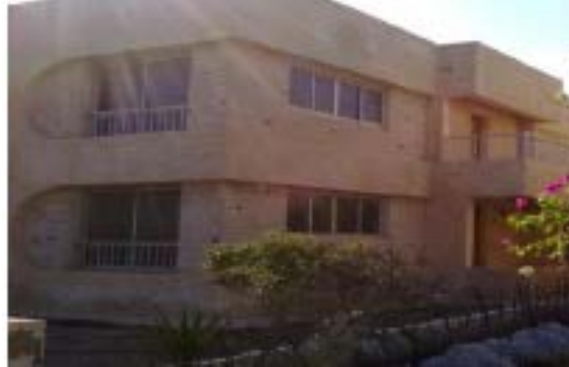
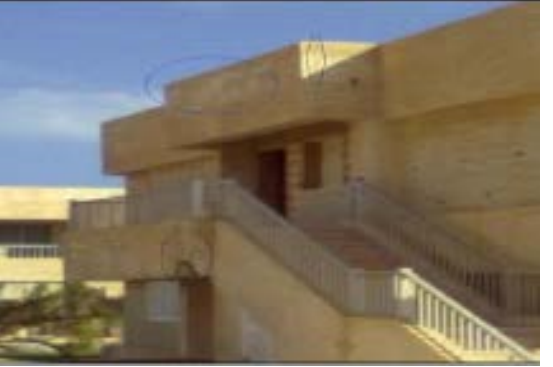
<p>Moisture damage by rain and humidity: Cladded parts of the wall were found in a very good condition</p>	<p>Moisture damage by rain and humidity: Efflorescence on parapet wall - and at ground floor walls exposed to garden's moisture and surface water. Step Crack at the corner of stair case side wall</p>

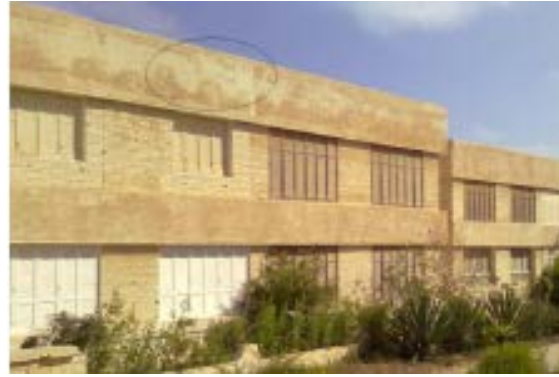
<p>Moisture damage by rain and irrigation system: Cladded parts of the wall were found in a very good condition</p>	<p>Moisture damage by rain and irrigation system: Faded color due to high exposure to UV. Slight cracking at the corner of parapet wall-severe damage to render layer (at the staircase side /parapet wall), at the parts where accumulated driving rain water over flow and fall off the wall side, causing complete wetting of the stair case walls</p>
Fourth Row: Exposure: Low	Orientation: Southern Façade

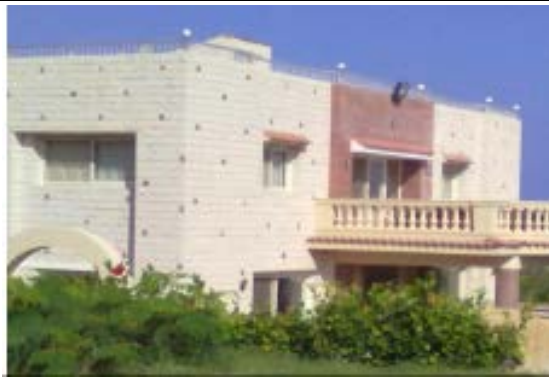
<p>Moisture damage by rain and UV: High water absorption during driving rainfall months: parapets absorb most water, and dry out unevenly, leaving wet patches , and efflorescence , color bleach of wall render caused by long exposure to UV radiation externally</p>
Fourth Row: Exposure: Average	Orientation: Eastern Façade Walls

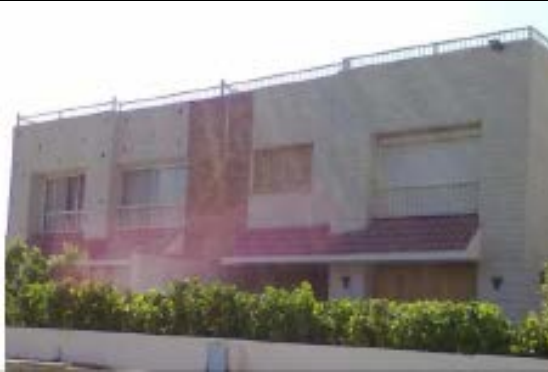
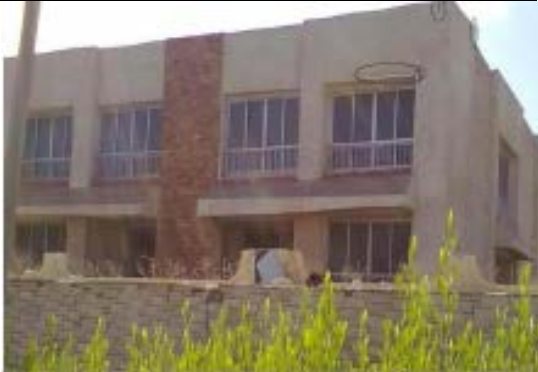
Stone /Brick Veneer	Render Finish
Forth Row: Exposure: Average	Orientation: North Façade

Moisture damage by rain: Limestone and brick cladded parts of the façade (including corners) were in a very good condition	Moisture damage by rain: Main damages in rendered parts are : - Corner cracks in parapet wall - Partial fracture in the concrete cover of window sills - Partial Peel off of render finish
